Damage Evaluation Report

“SALT SHAKER”

2002 Shamrock 290 WA

DAMAGE EVALUATION REPORT

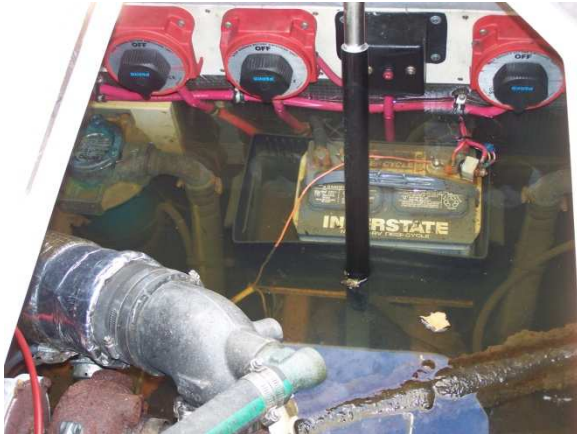
Photos 1, 2, and 3 (provided by the owner) show the extent of submersion in the main cabin and engine room at time of discovery. Pictures 4, 5, and 6 shows the engine room and main cabin as it appeared on the day of inspection.

The engine compartment was filled to approximately $\frac{3}{4}$ of its depth (this varied due to the angle of the vessel) meaning both transmissions were completely submerged and the engines were submerged aft to a point just above the bottom of the turbochargers.

Photo 1: Flooded engine compartment

1. Based on estimated length of submersion, lack of damage control after submersion, and the amount of external corrosion noted, it is assumed both engines and transmissions are beyond the point of repair and will need to be replaced.

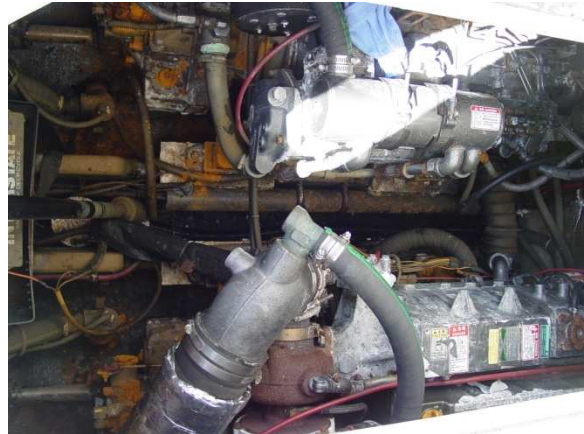
Another area of concern is possible water intrusion into vessel stringers and frames, particularly those in the engine room (which bear the weight of the engines). Although percussion sounding of these stringers (where accessible) showed no issues, the surveyor was unable to fully inspect due to the presence of the above mentioned oily slurry, which coated the entire engine compartment bilge and sides – the same was true of the remaining cockpit and main cabin bilge areas.

Photo 4: Engine compartment

2. Based on observed condition, it is assumed that all remaining equipment in the engine room will require replacement. The same is true of any additional equipment in the bilge of the main cabin and cockpit bilge aft damaged during the submersion.

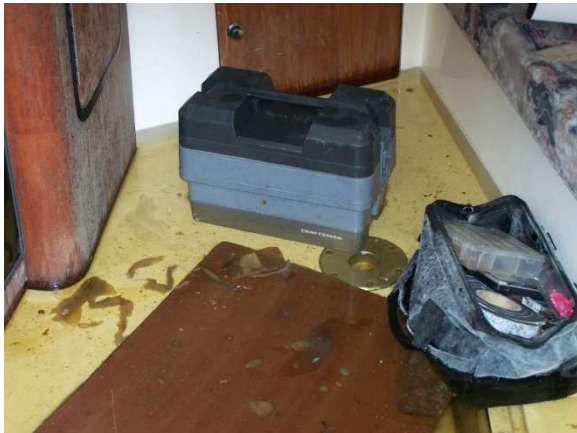
Based on the photos provided by the owner and observations made during the inspection (measurements of interior watermarks, etc) the main cabin filled to a depth at least 4 inches above the cabin sole – more so aft due to the angle of the hull. Water

Photo 2: Flooded main cabin

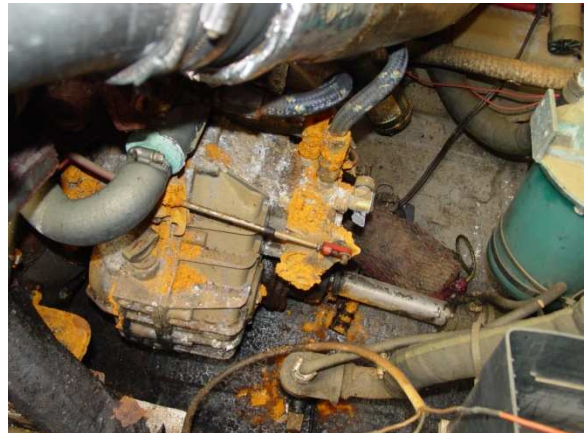
Photo 5: Example of engine corrosion

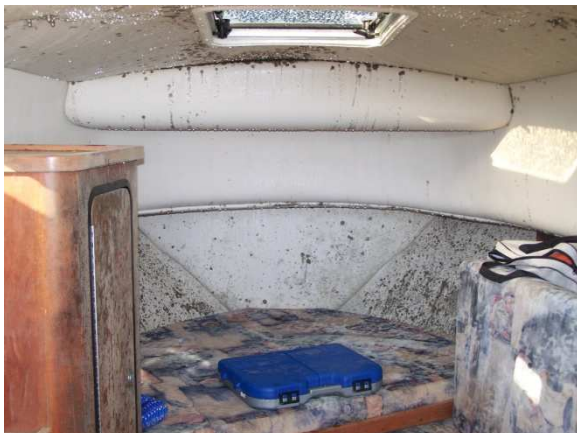
damage to the lower edges of the wood cabinet framework, cabinet doors, etc, was also sighted and there was a significant amount of mold and mildew present.

Photo 3: Mold and mildew in main cabin

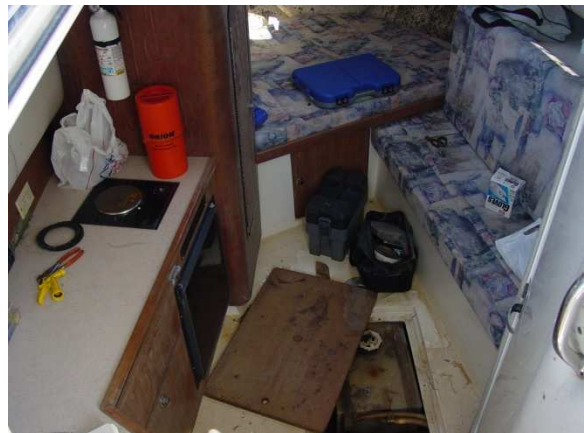
Photo 6: Main cabin
